New York State Department of Transportation

Yellow Flag NB2222W015

BIN: 1065318

Location: Span 154 – S1 at Pier 153 over 3rd Avenue Westbound

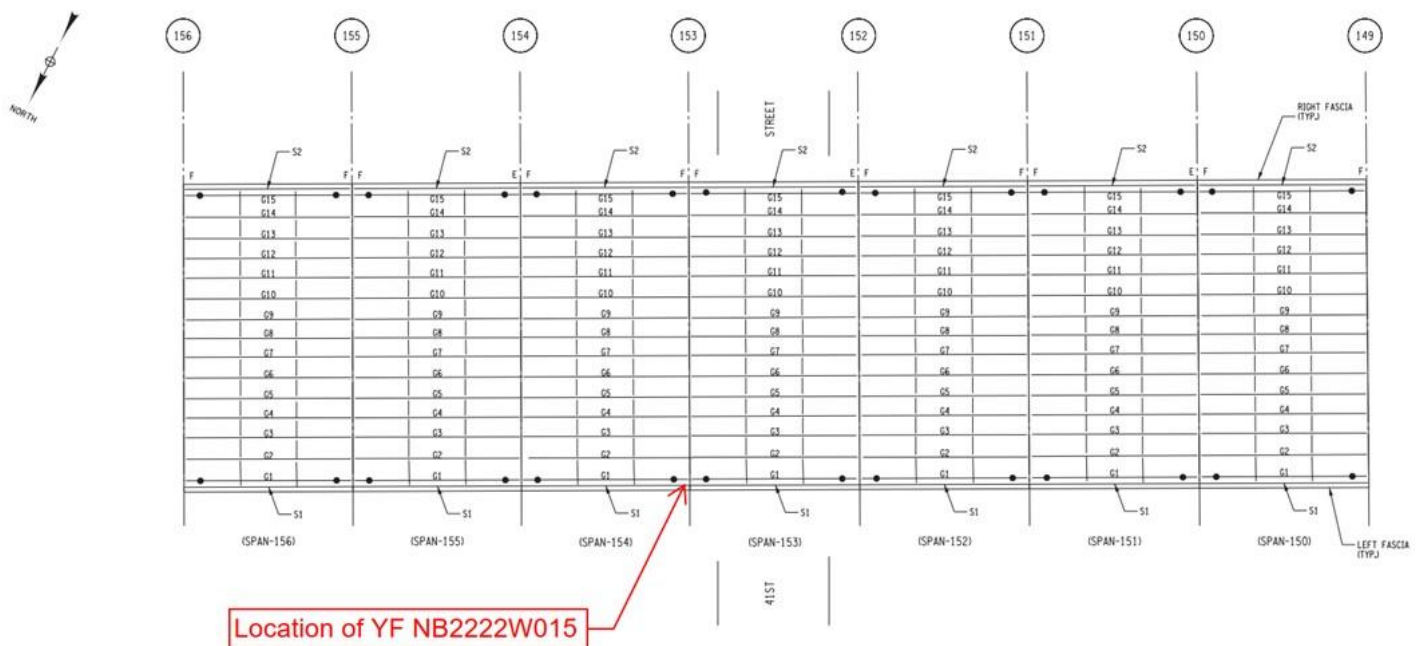
Flag PhotographsPhoto Number: **1**Photo Filename: **1065318 Span 154 Framing Plan.jpg**

**Attachment Description: SPAN 154 FRAMING PLAN**

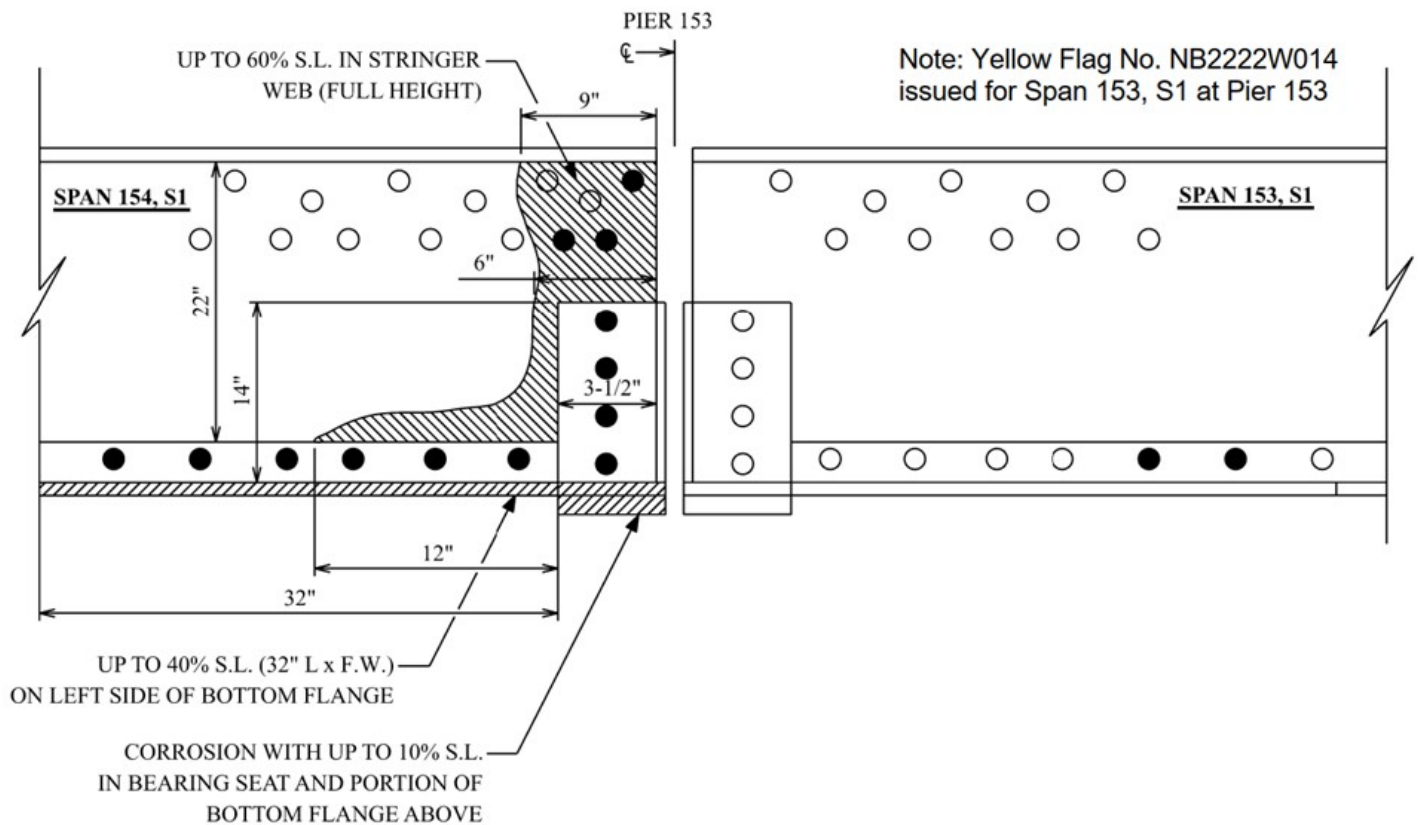
Photo Number: 2

Description: Stringer S1 end at Pier 153 exhibits severe corrosion with up to 60% section loss in the web for height of 22", adjacent to the connection angle. Four (4) rivets in the connection angle, six (6) rivets in the bottom flange angle and three (3) rivets in web exhibit 10% to 15% section loss in rivet heads.

LEFT FACE OF STRINGER S1 AT PIER 153(LOOKING RIGHT)

● UP TO 10% - 15 % SECTION LOSS IN RIVET HEAD

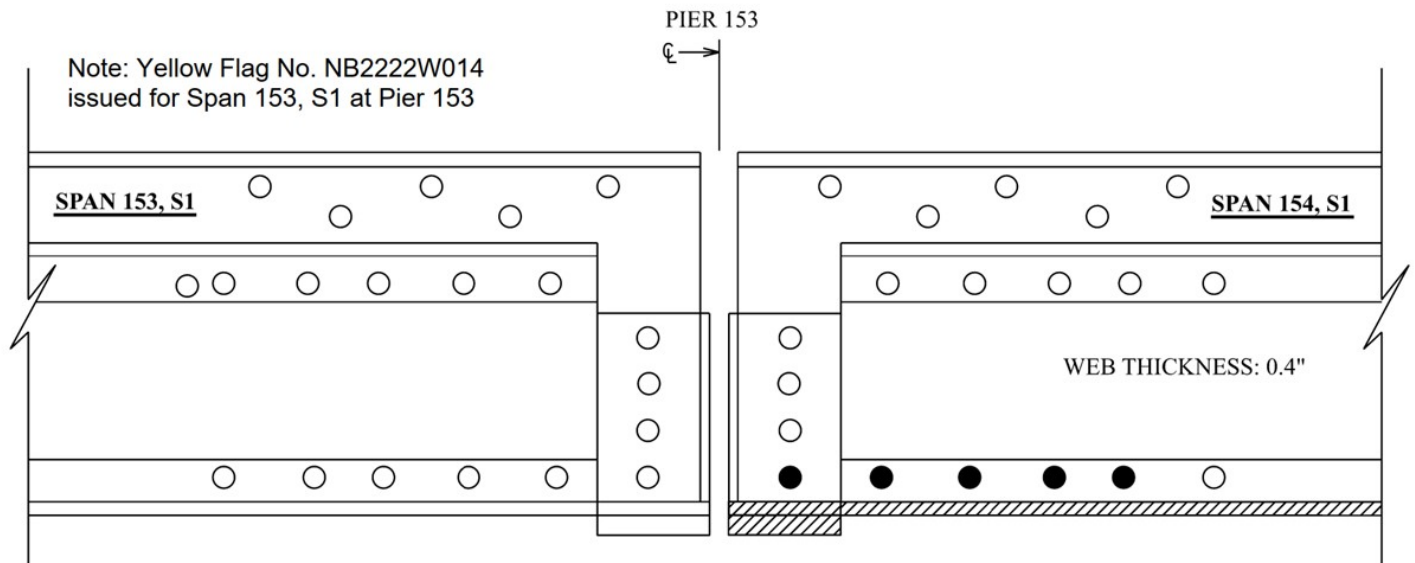
Photo Number: 3

The outstanding leg of the bottom flange angle exhibits up to 40% section loss (32"L x full width). The stringer bearing seat at the begin face of Pier 153 exhibits corrosion with up to 10% section loss.

- UP TO 10% - 15 % SECTION LOSS IN RIVET HEAD

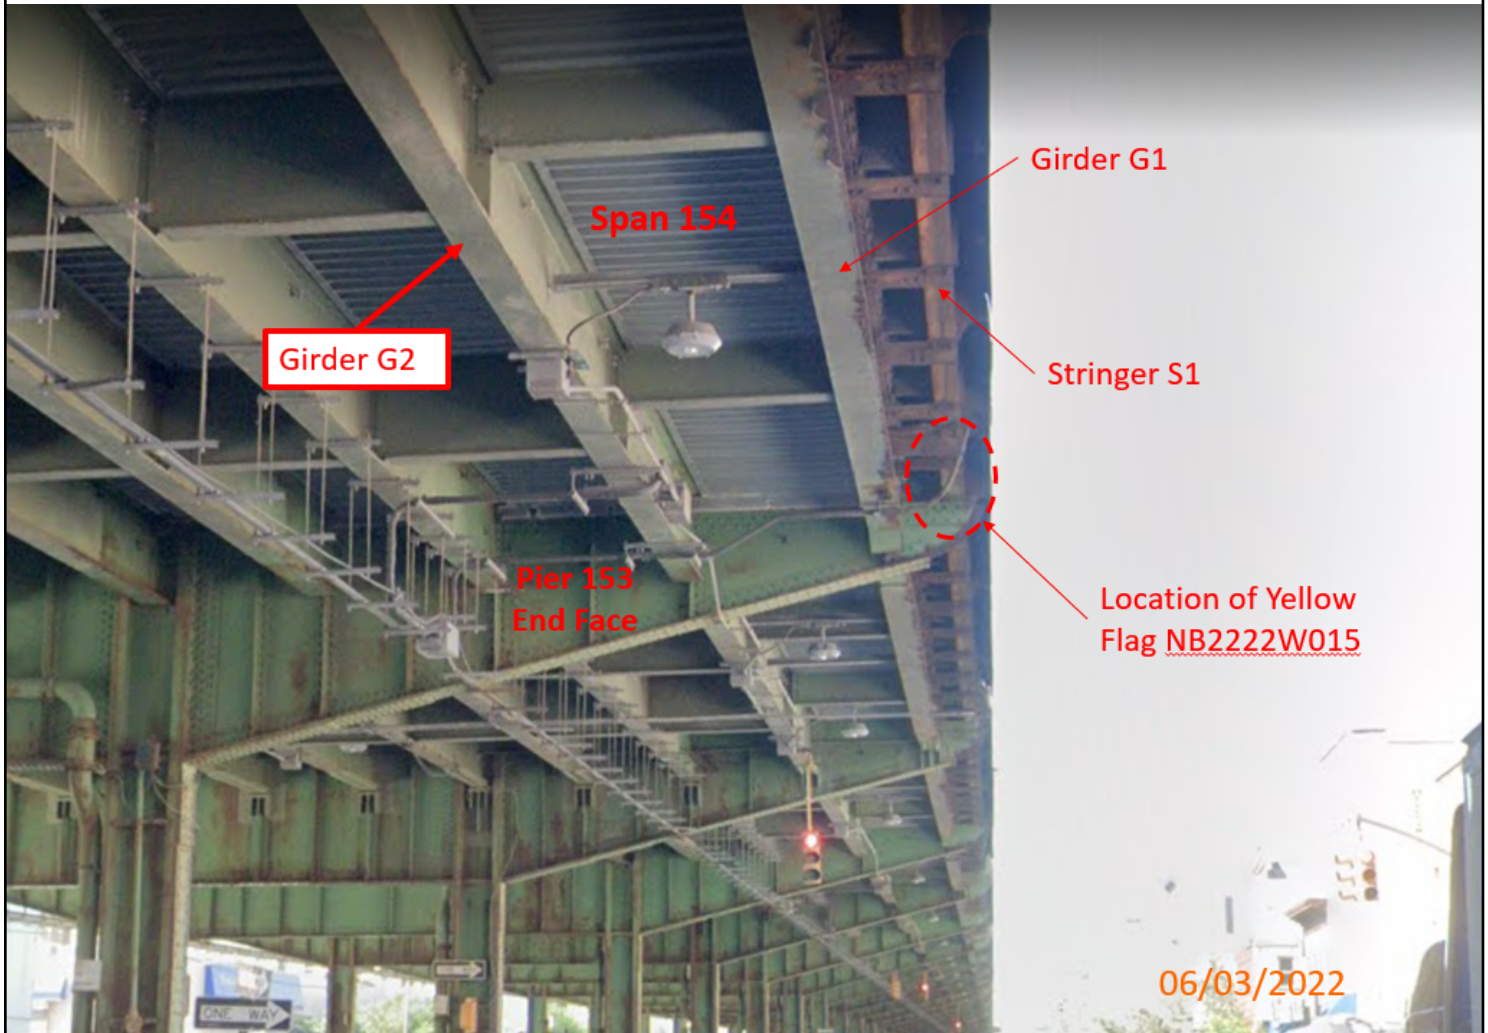
Photo Number: 4

Attachment Description: General view of flag location in Span 154 at Pier 153. Looking begin.

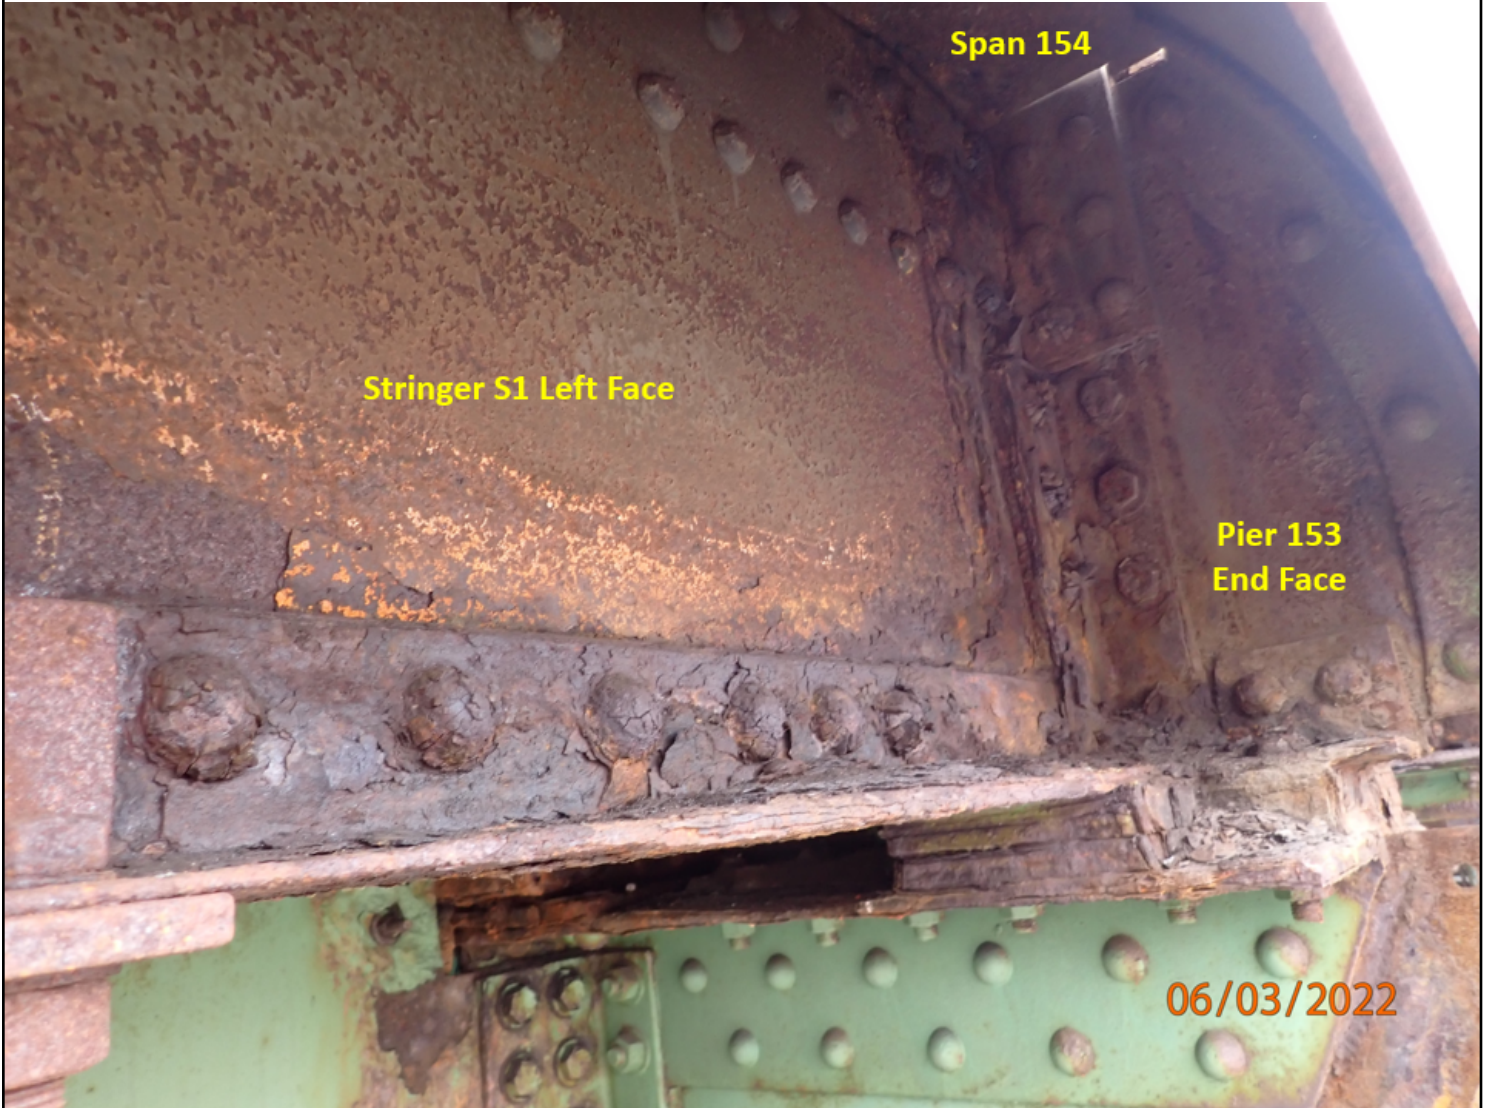
Photo Number: 5

Attachment Description: Span 154, Stringer S1 at Pier 153 - General view of left side of stringer web. Looking begin - right.

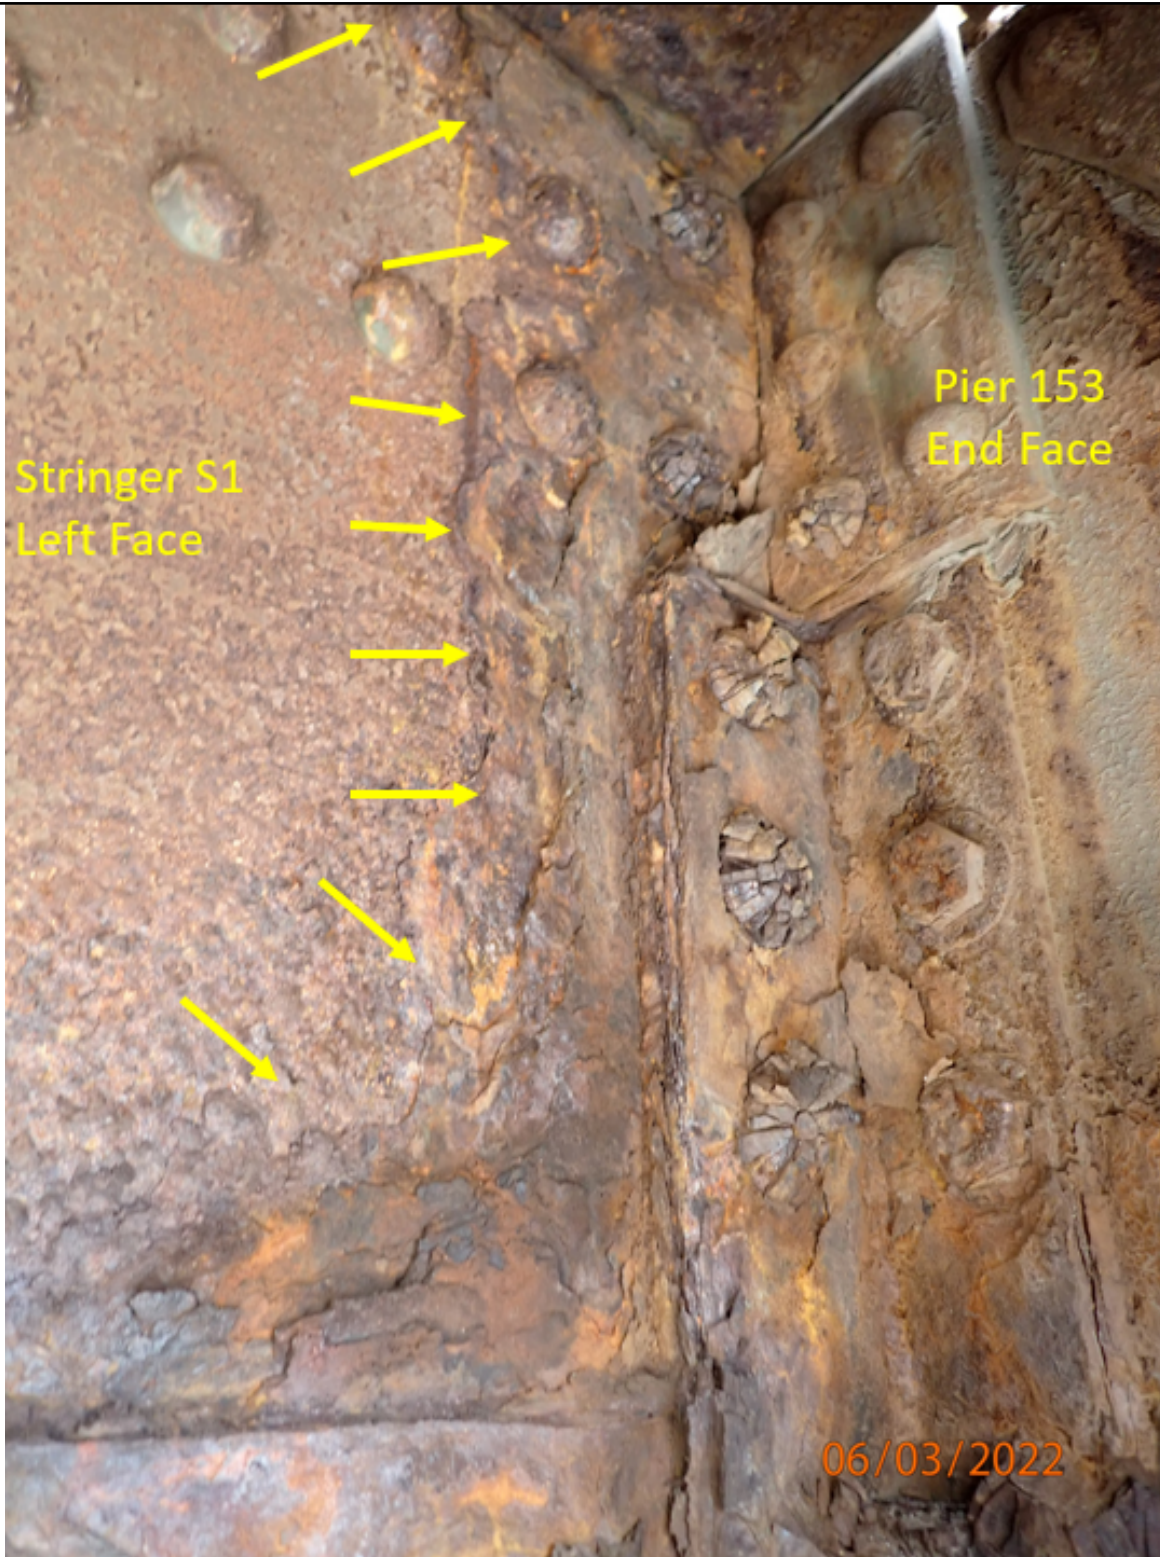
Photo Number: 6

Attachment Description: Span 154, Stringer S1 at Pier 153 - Close-up view of left side of stringer web. Looking begin - right.

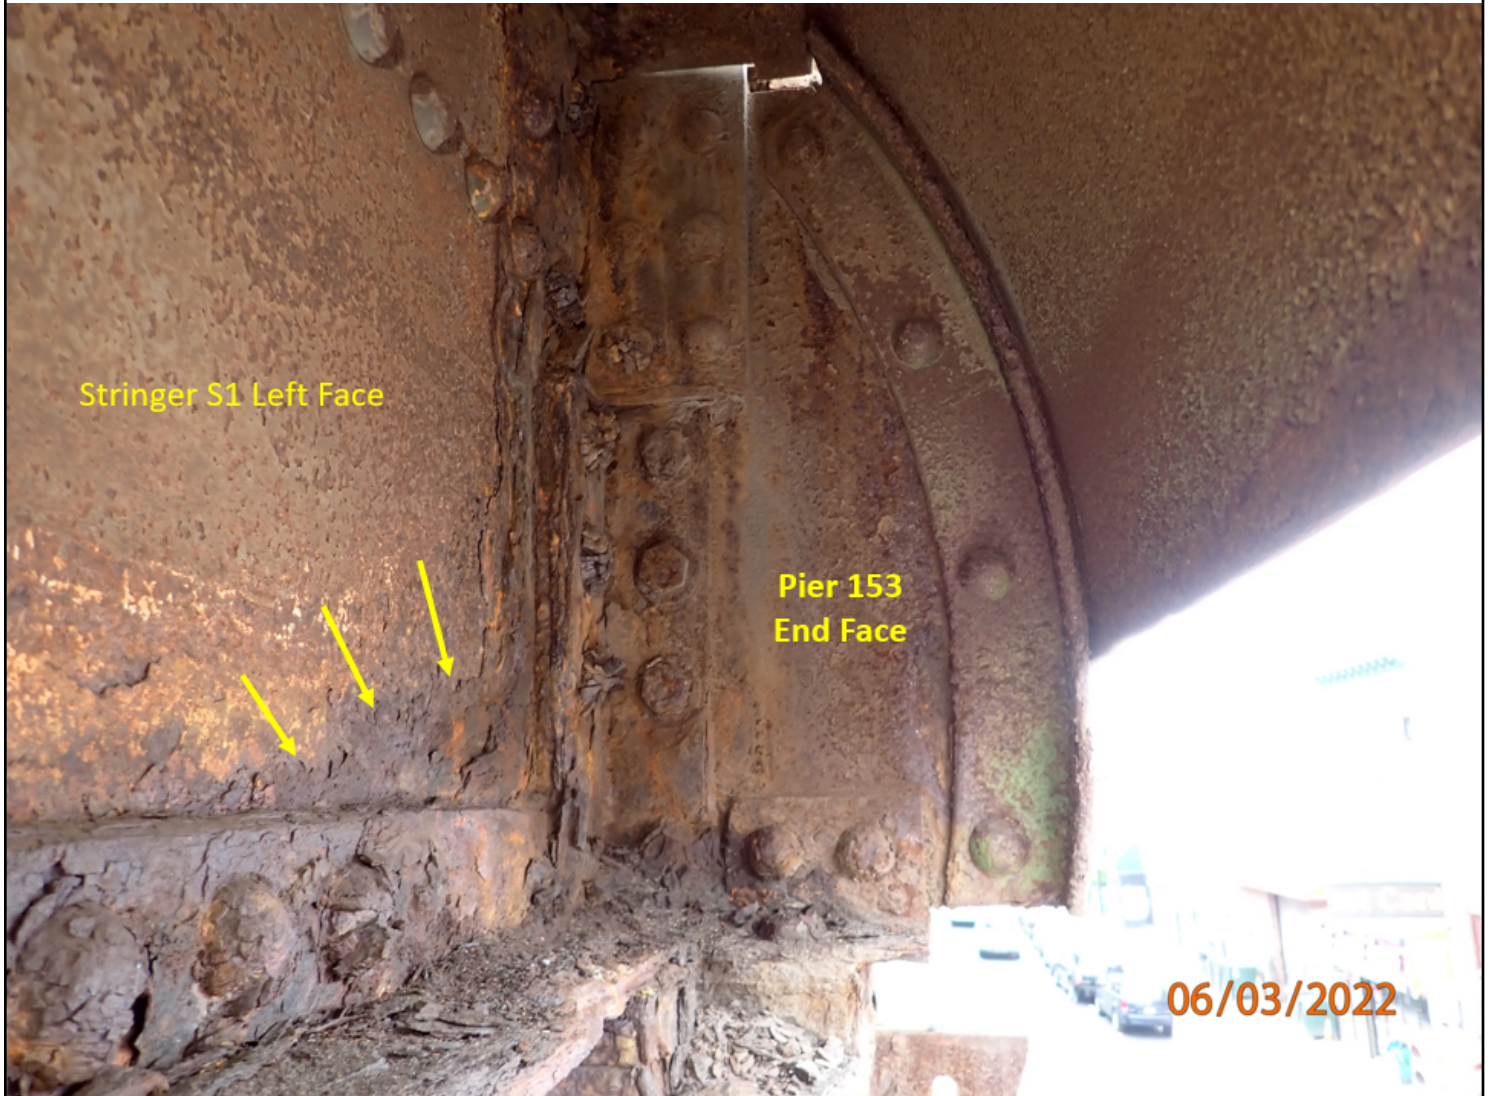
Photo Number: 7

Attachment Description: Close up view of Span 154, Stringer S1 at Pier 153 - Section loss in bottom flange and in angle leg rivets on left side of stringer web. Looking begin.
